October 2002

MAINTENANCE BULLETIN

Alfa Company

Construction Battalion Center

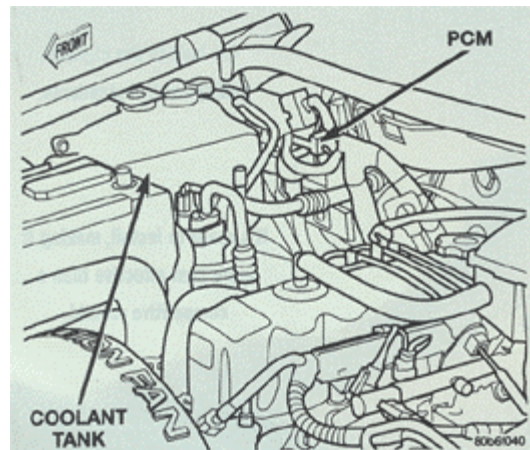
If the TPS signal doesn't correspond to other sensor inputs that can be used to measure engine load, the PCM, located near the coolant tank, may set a fault code.

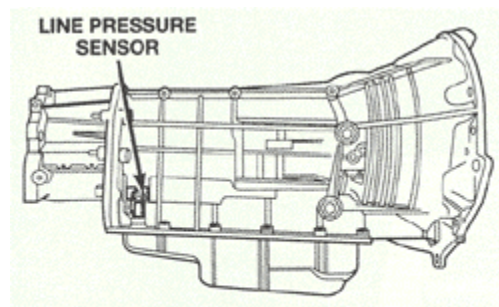
Immediate shutdown mode, where the TCM de-energizes the transmission control relay and locks the transmission in gear, is usually caused by an internal transmission solenoid, sensor or pressure switch problem.

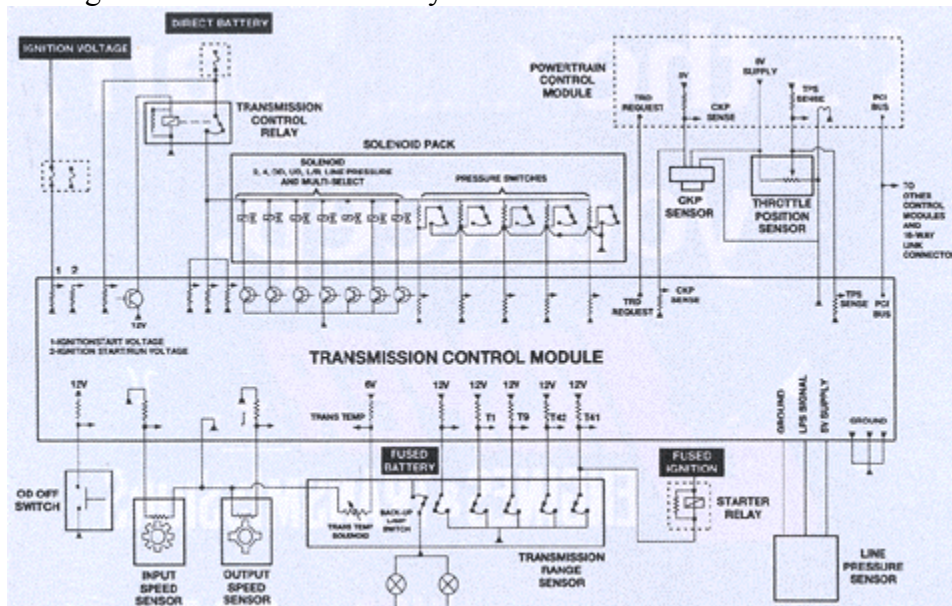
If a vehicle has a data bus communication problem between the TCM and PCM, you probably won't be able to access any transmission codes until the wiring problem is fixed.
